# Screen-Film Contact Test Tools

## *Meshes for checks of the contact between film and screen of X-ray film cassettes*

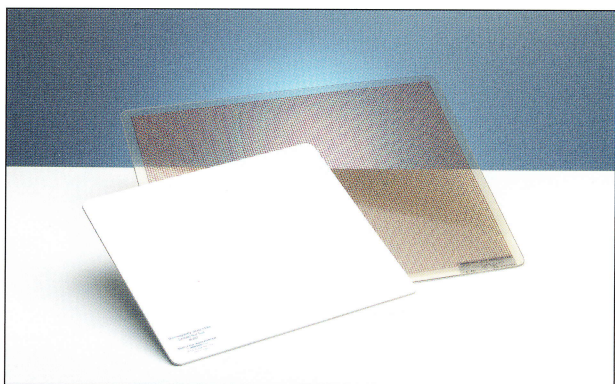
- ▶ Enable fast and easy quality checks of film cassettes
- ▶ Copper mesh embedded in plastic plate
- ▶ Two types are available:
  - ▷ Radiography test tool 36.5 cm x 43 cm with 8 wires per inch ( $\approx 3$  wires per cm), 0.7 mm thick
  - ▷ Mammography test tool 26 cm x 31 cm with 40 wires per inch ( $\approx 16$  wires per cm), 0.26 mm thick

Poor image quality of X-ray films can be caused by film-screen contact problems in the film cassette. These problems can be determined easily by laying the mesh over the cassette and exposing the film. Blurring or distortion of the screen image across the film indicates poor film-screen contact. The screen-film contact of the X-ray film cassettes should be checked frequently to ensure image quality.
